El Paso Downtown Management District Quarterly Progress Report #7 (3Q22)

FY2020 EPA Brownfield Assessment Coalition Grant (BF-01F87401)

July 26, 2022

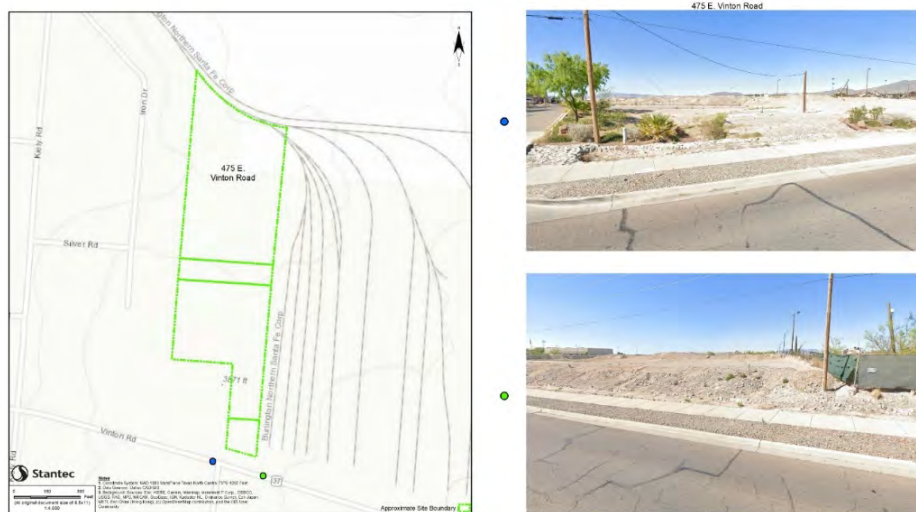
Underutilized 11.6-acre property used to store waste (“shredder fluff”) from the adjacent auto/metals salvage/recycling facility (see images below). Reuse plans include a community park. Other details include:

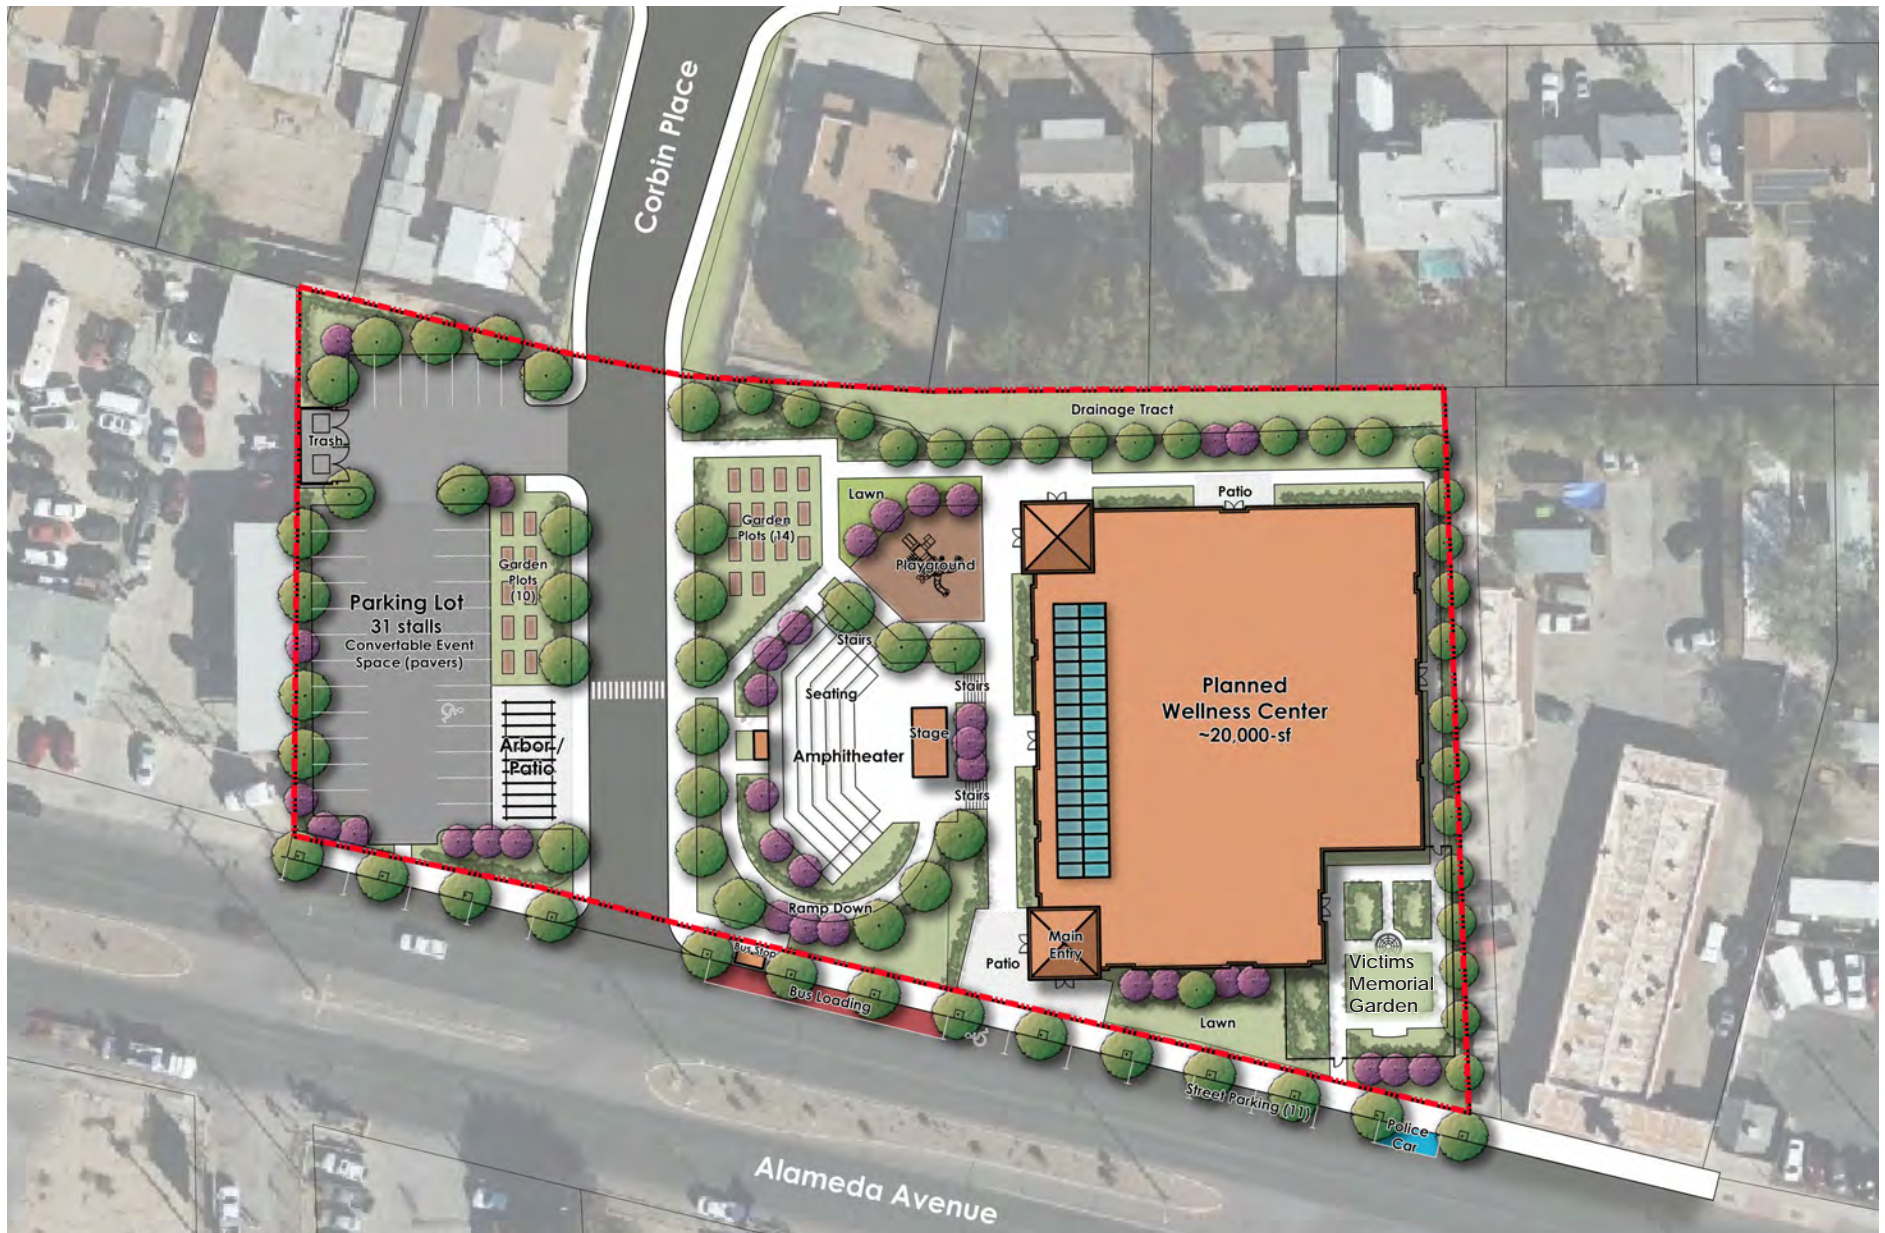
Figure ES2. Reuse Plan

Parking/Convertible Event Space – The reuse plan depicts a new parking lot to accommodate up to 31 motor vehicles. Portions of the parking area are planned with concrete pavers so the space could be used for community event space (in lieu of parking). An arbor structure and paver area are planned between the parking lot and Corbin Place to accommodate community events and provide shade elements. The reuse plan will include frontage improvements along Alameda Avenue which would include 11 striped street parking stalls, a designated stall for a police/sheriff vehicle, and a bus loading area (and shelter). The frontage improvements also include 10-ft wide sidewalks and evenly spaced tree wells.

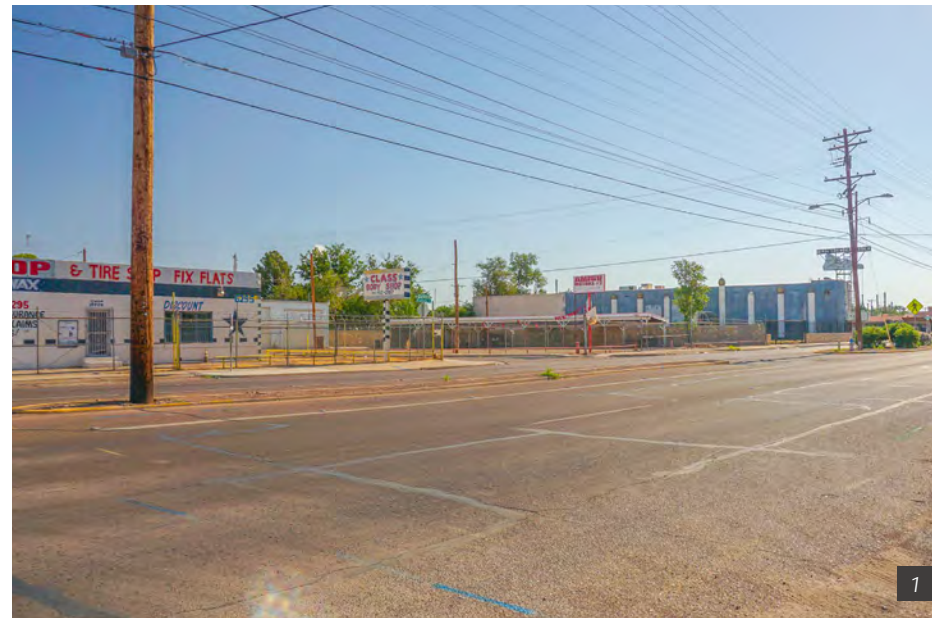
1. Recent photograph of the Corbin-Sambrano property - the former vehicle dealership and theater building in distance.

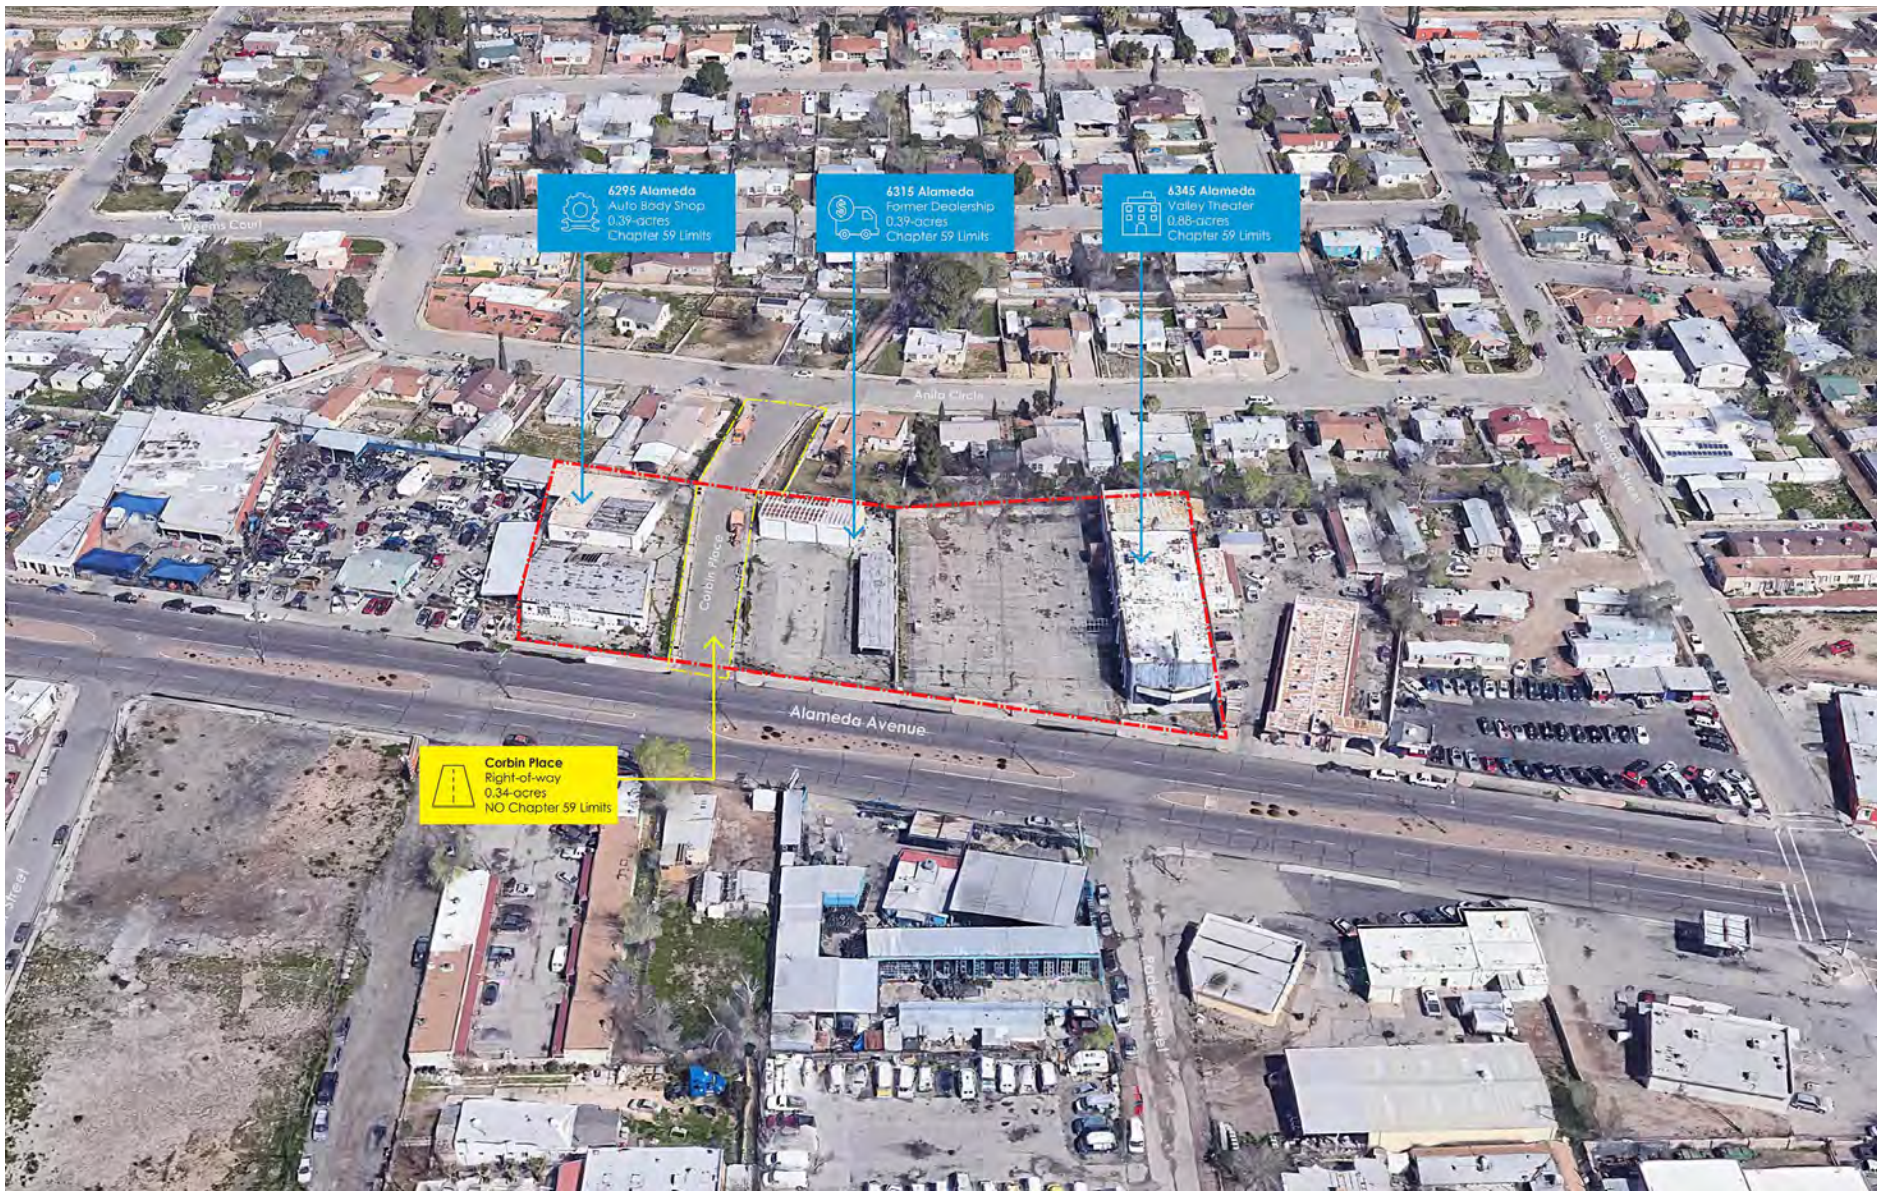
Figure 2.1.1. Site Conditions Map
(Source: Google Earth Pro)

Existing Buildings and Site Components – The following bullets summarize the existing site conditions for each of the three tax lots comprising the Corbin-Sambrano property.

- **6295 Alameda Avenue** – The western-most lot includes two structures; a 1-story, 3,680 square-foot building constructed in 1975 with a 1983 addition and a 1-story, 2,800 square-foot building constructed in 1984. The lot is unoccupied but previously supported an autobody shop business. The buildings are in fair condition, lack historical significance, and appear to have adaptive reuse potential to support new uses/tenants (and including those types of uses limited by Chapter 59).

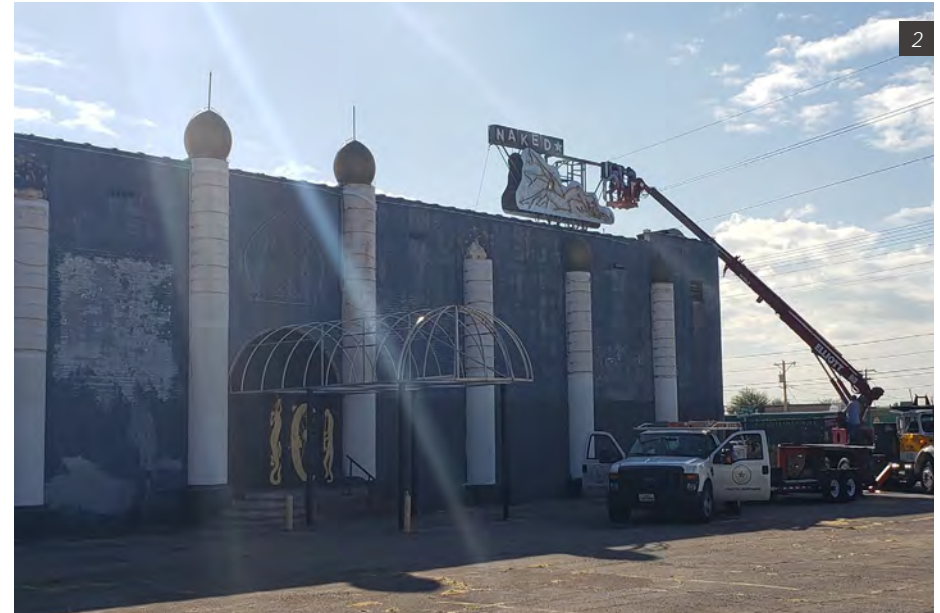
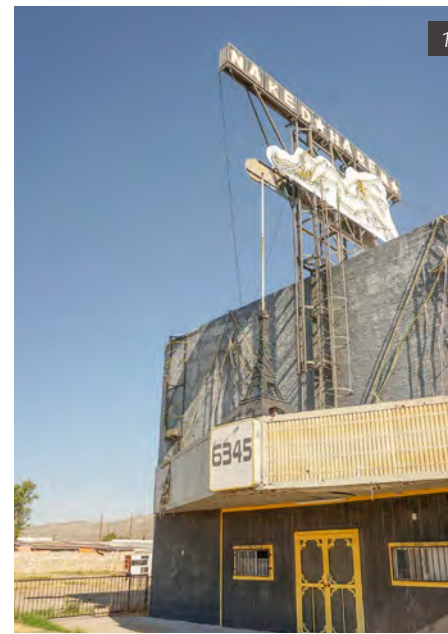
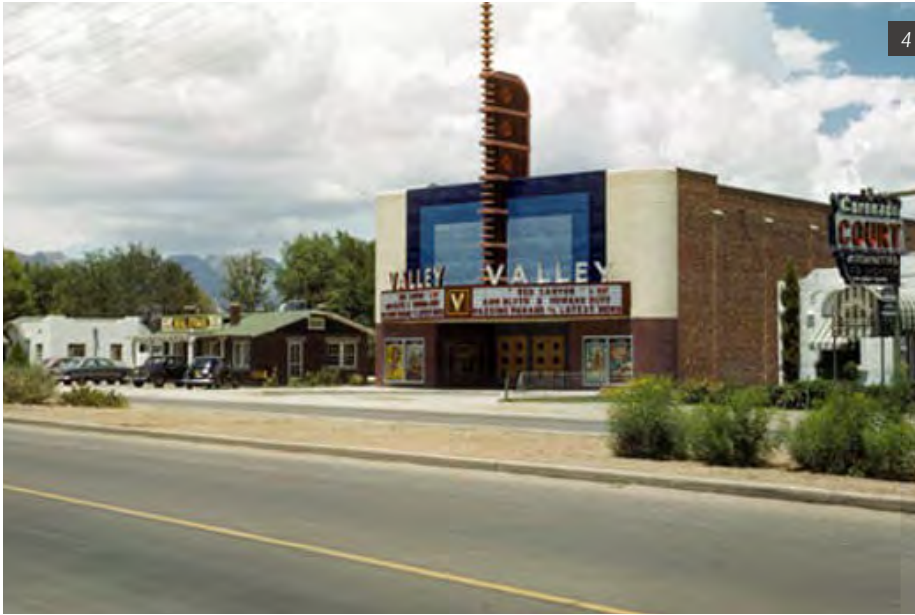
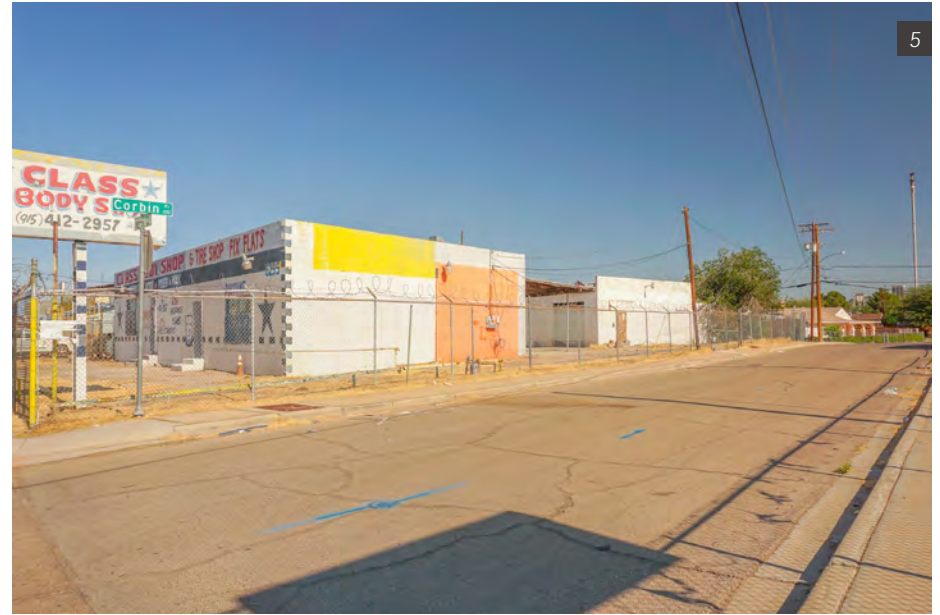
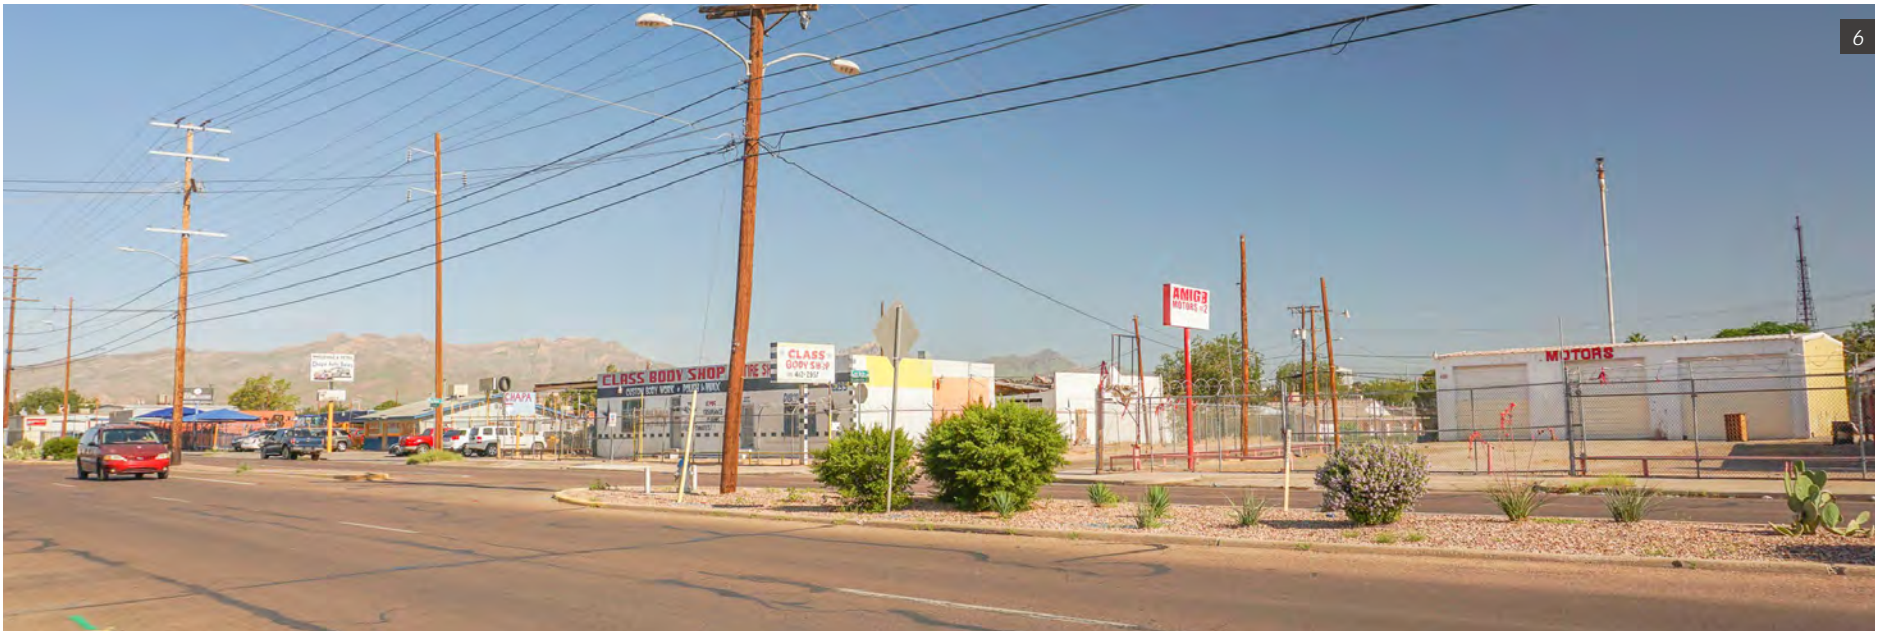
1. Image of the former theater building at 6345 Alameda Avenue (the neon sign has since been removed). | 2 & 3. Images of the sign removal from the former theater building (street facing and side facades). | 4. Historical photograph of the Valley Theater building (Source: CinemaTreasures.com). | 5. View of the former autobody shop building from as seen from Corbin Place at 6295 Alameda Avenue. | 6. Streetview of the former autobody shop and vehicle dealership buildings - 6295 Alameda Avenue (left) and 6315 Alameda Avenue (right).

- **6345 Alameda Avenue** – The eastern-most lot includes the Valley Theater building which was originally constructed in 1948. The building operated as a cinema (under various names) until 1973; it was later used as an adult entertainment establishment through approximately 2006. The building has historical significance though iconic architectural elements are generally limited to the marquee sign on the street-facing facade. Adaptive reuse potential for community-serving uses is somewhat unknown and would require additional building assessment by an architect and structural engineer.

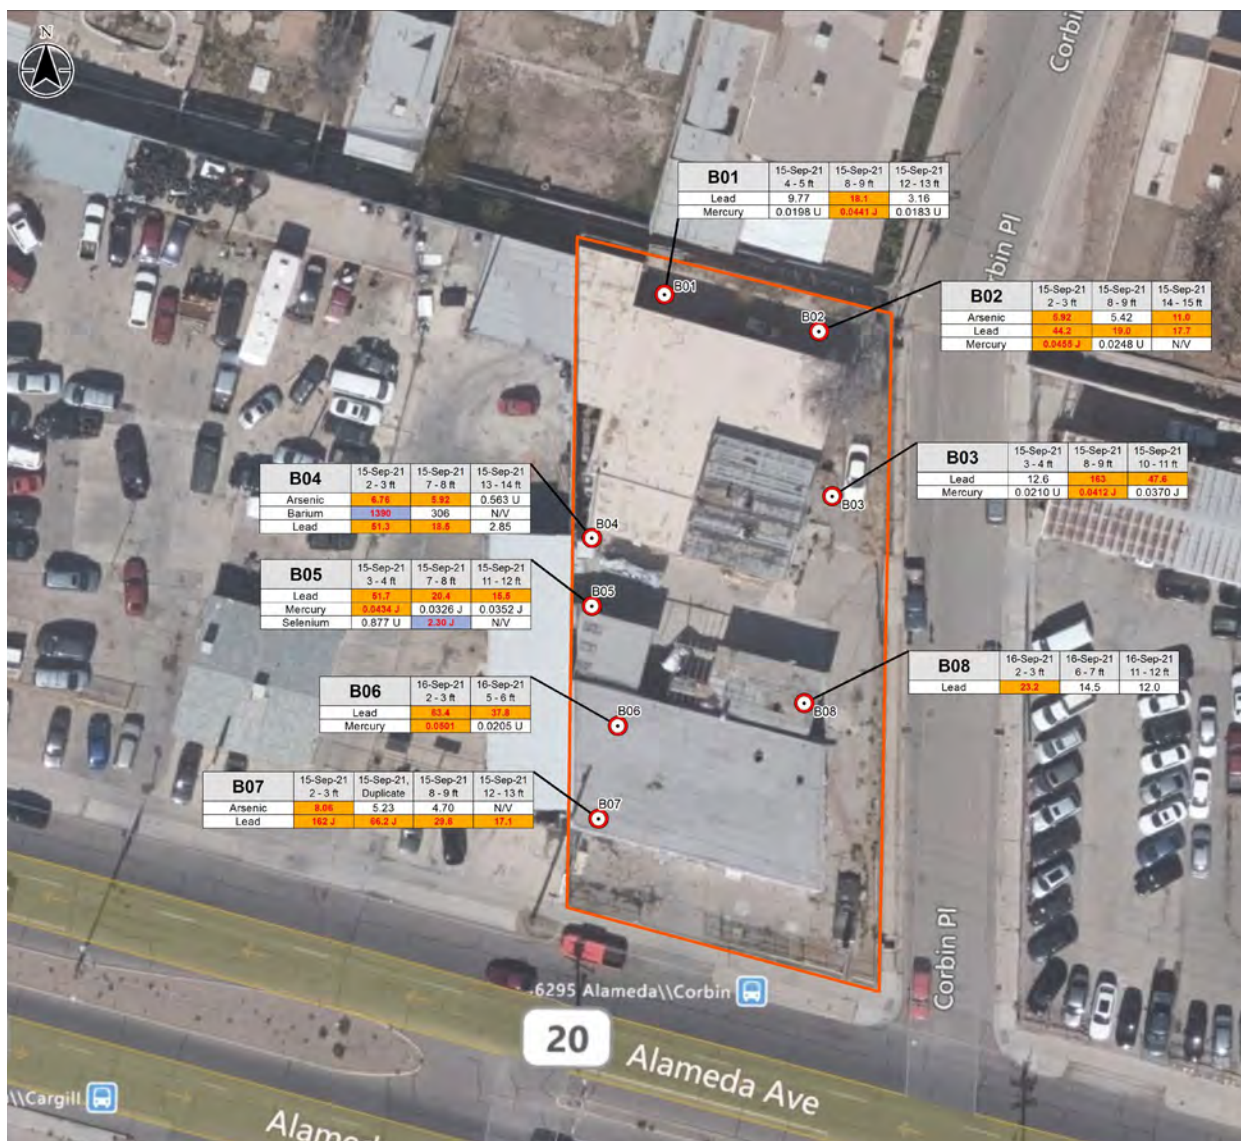
Figure 2.5.1. Summary of Soil Analytical Results - 6295 Alameda Avenue

- Arsenic was detected above the applicable protective concentration level (PCL) in six samples at depths ranging from 2-15 feet bgs.
- Barium was detected in one soil sample above the applicable PCL at a depth of 2-3 feet bgs.
- Lead was detected above the applicable PCL in 17 soil samples.
- Mercury was detected above the applicable PCL in five soil samples.
- Selenium was detected in one soil sample equal to the applicable PCL of 2.3 mg/kg.
- The vertical and horizontal extent of arsenic and lead in soil has not been delineated by the borings advanced during this investigation.

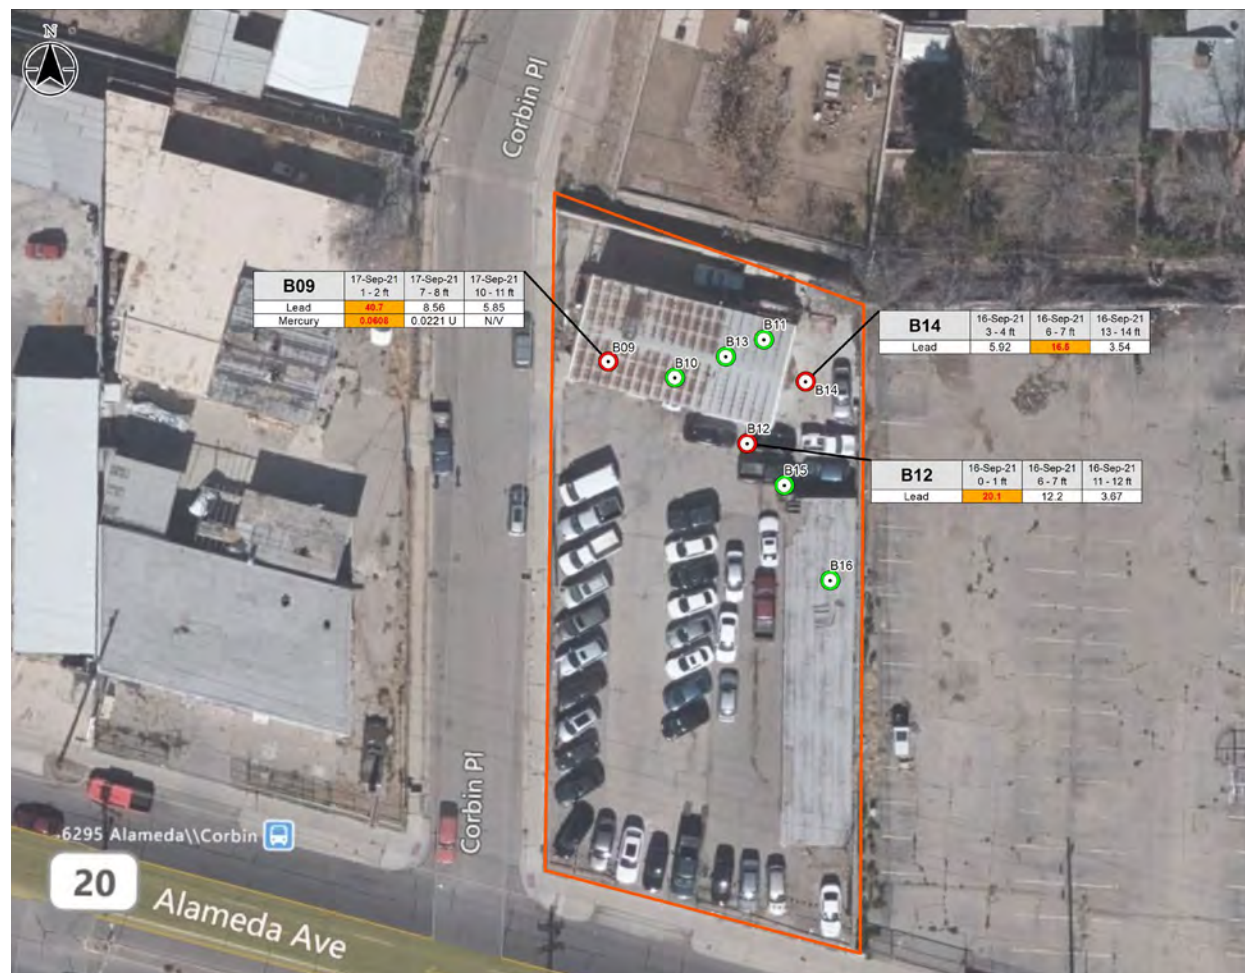
Figure 2.5.2. Summary of Soil Analytical Results - 6315 Alameda Avenue

- Lead was detected above the applicable PCL in three soil samples.
- Mercury was detected above the applicable PCL in one soil sample.
- The vertical extent of metals in soil appears to be delineated with the borings installed at 6315 Alameda; however, the horizontal extent of metals in soil has not been delineated.

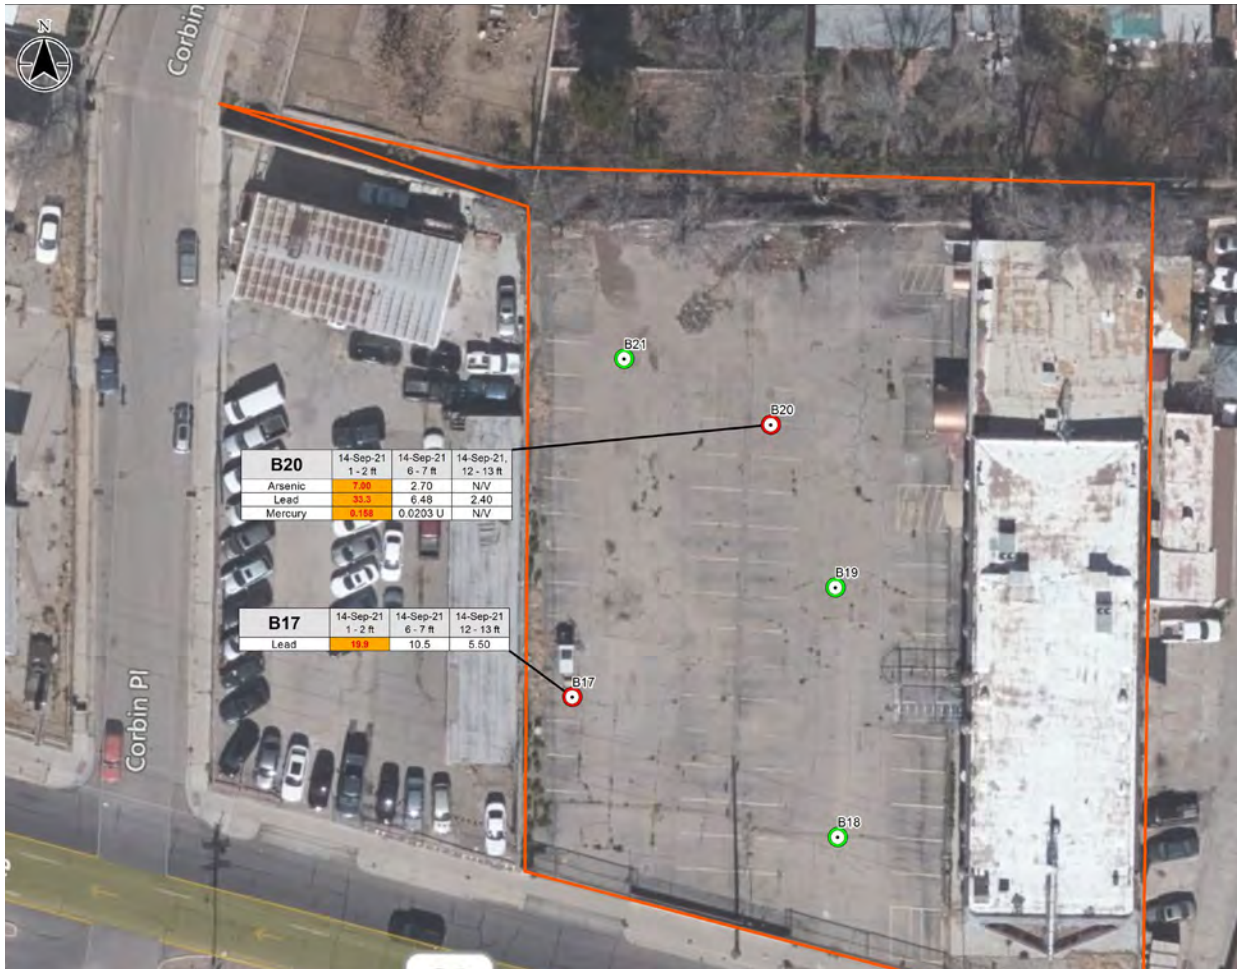
Figure 2.5.3. Summary of Soil Analytical Results - 6345 Alameda Avenue

- Arsenic was detected in one soil sample above the applicable PCL.
- Lead was detected above the applicable PCL in two soil samples.
- Mercury was detected above the applicable PCL in one soil sample.
- The vertical extent of metals in soil appears to be delineated with the borings installed at 6345 Alameda; however, the horizontal extent of metals in soil is not delineated.

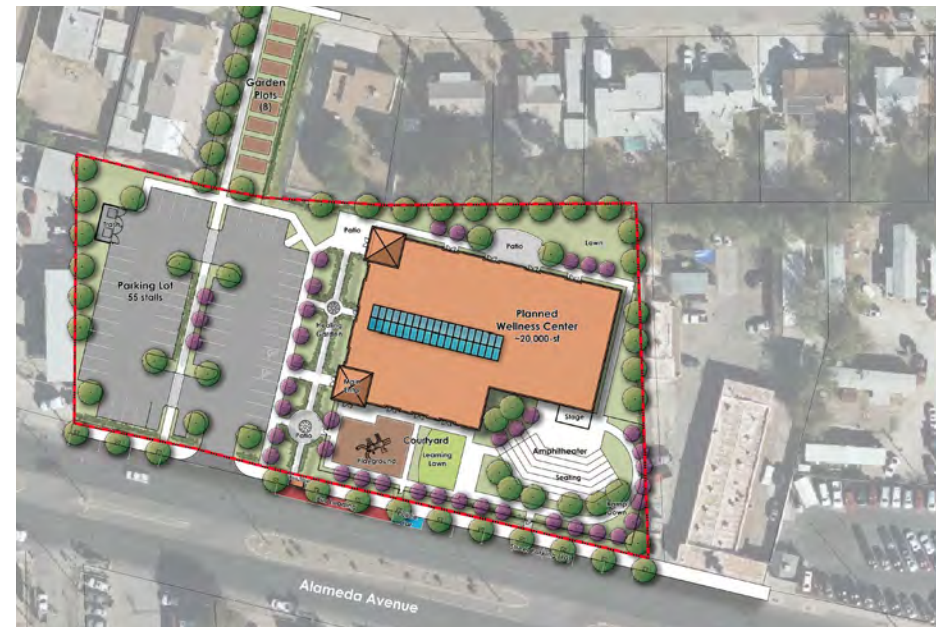
Figure 3.3.4. Concept Alternative B.2

Concept B.2 – This alternative includes a 20,000-sf wellness center with the most amount of green space. The healing garden would stretch along the entire west / front facade – visitors would pass through this space (it would also have great sunlight). A gated courtyard with a playground, learning lawn, and the amphitheater is planned along the Alameda Avenue frontage placing the outdoor community activity areas at a prominent location along the corridor.

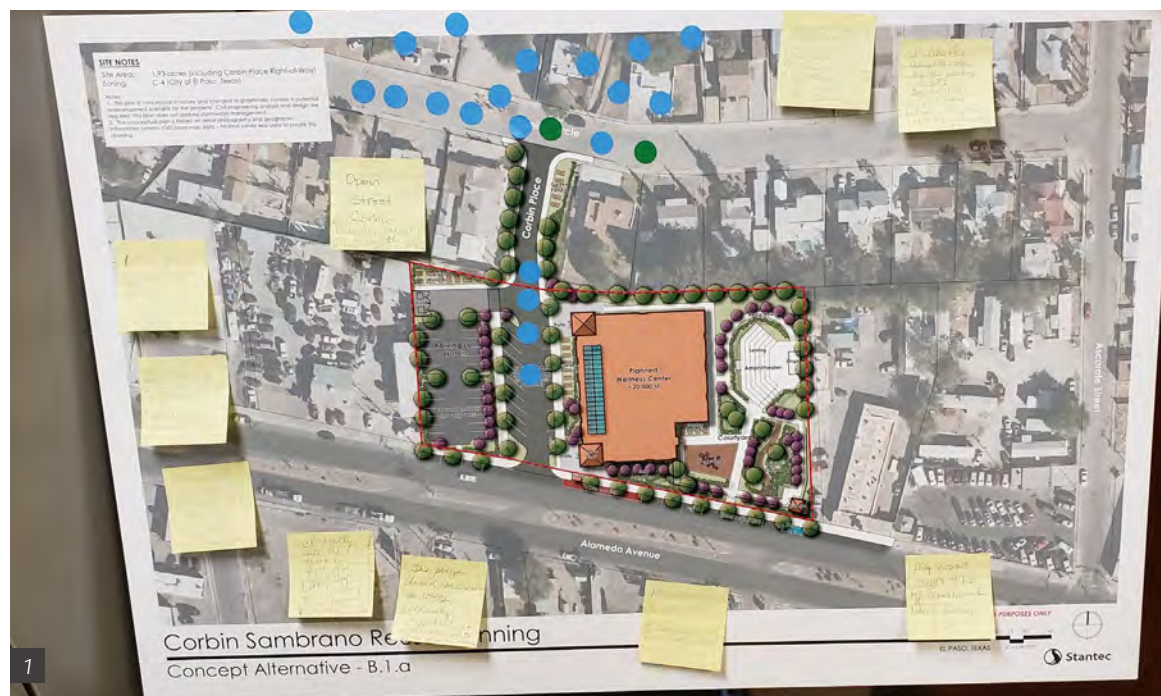
Community Feedback on the Plan Alternatives. 1. Depiction of the preferred alternative (B.1) with participant notes. | 2. Participant responses pertaining to Corbin Place design preferences (close, reduce/enhance, or leave as-is). | 3. Participant responses pertaining to the theater building (demolish or rehabilitate the structure).

- **Amphitheater:** Move the amphitheater to the west side of the building and along Corbin Place for additional visibility, access, and noise control.
- **Playground:** Move the playground to the back of the property and away from the busy Alameda Avenue thoroughfare.
- **Corbin Place:** Preserve Corbin Place (roadway) in its current configuration.

Additionally, participants were asked whether the theater building should be removed or adaptively reused for new community-serving uses. The majority of the participants indicated that the building should be removed to make way for new site improvements.

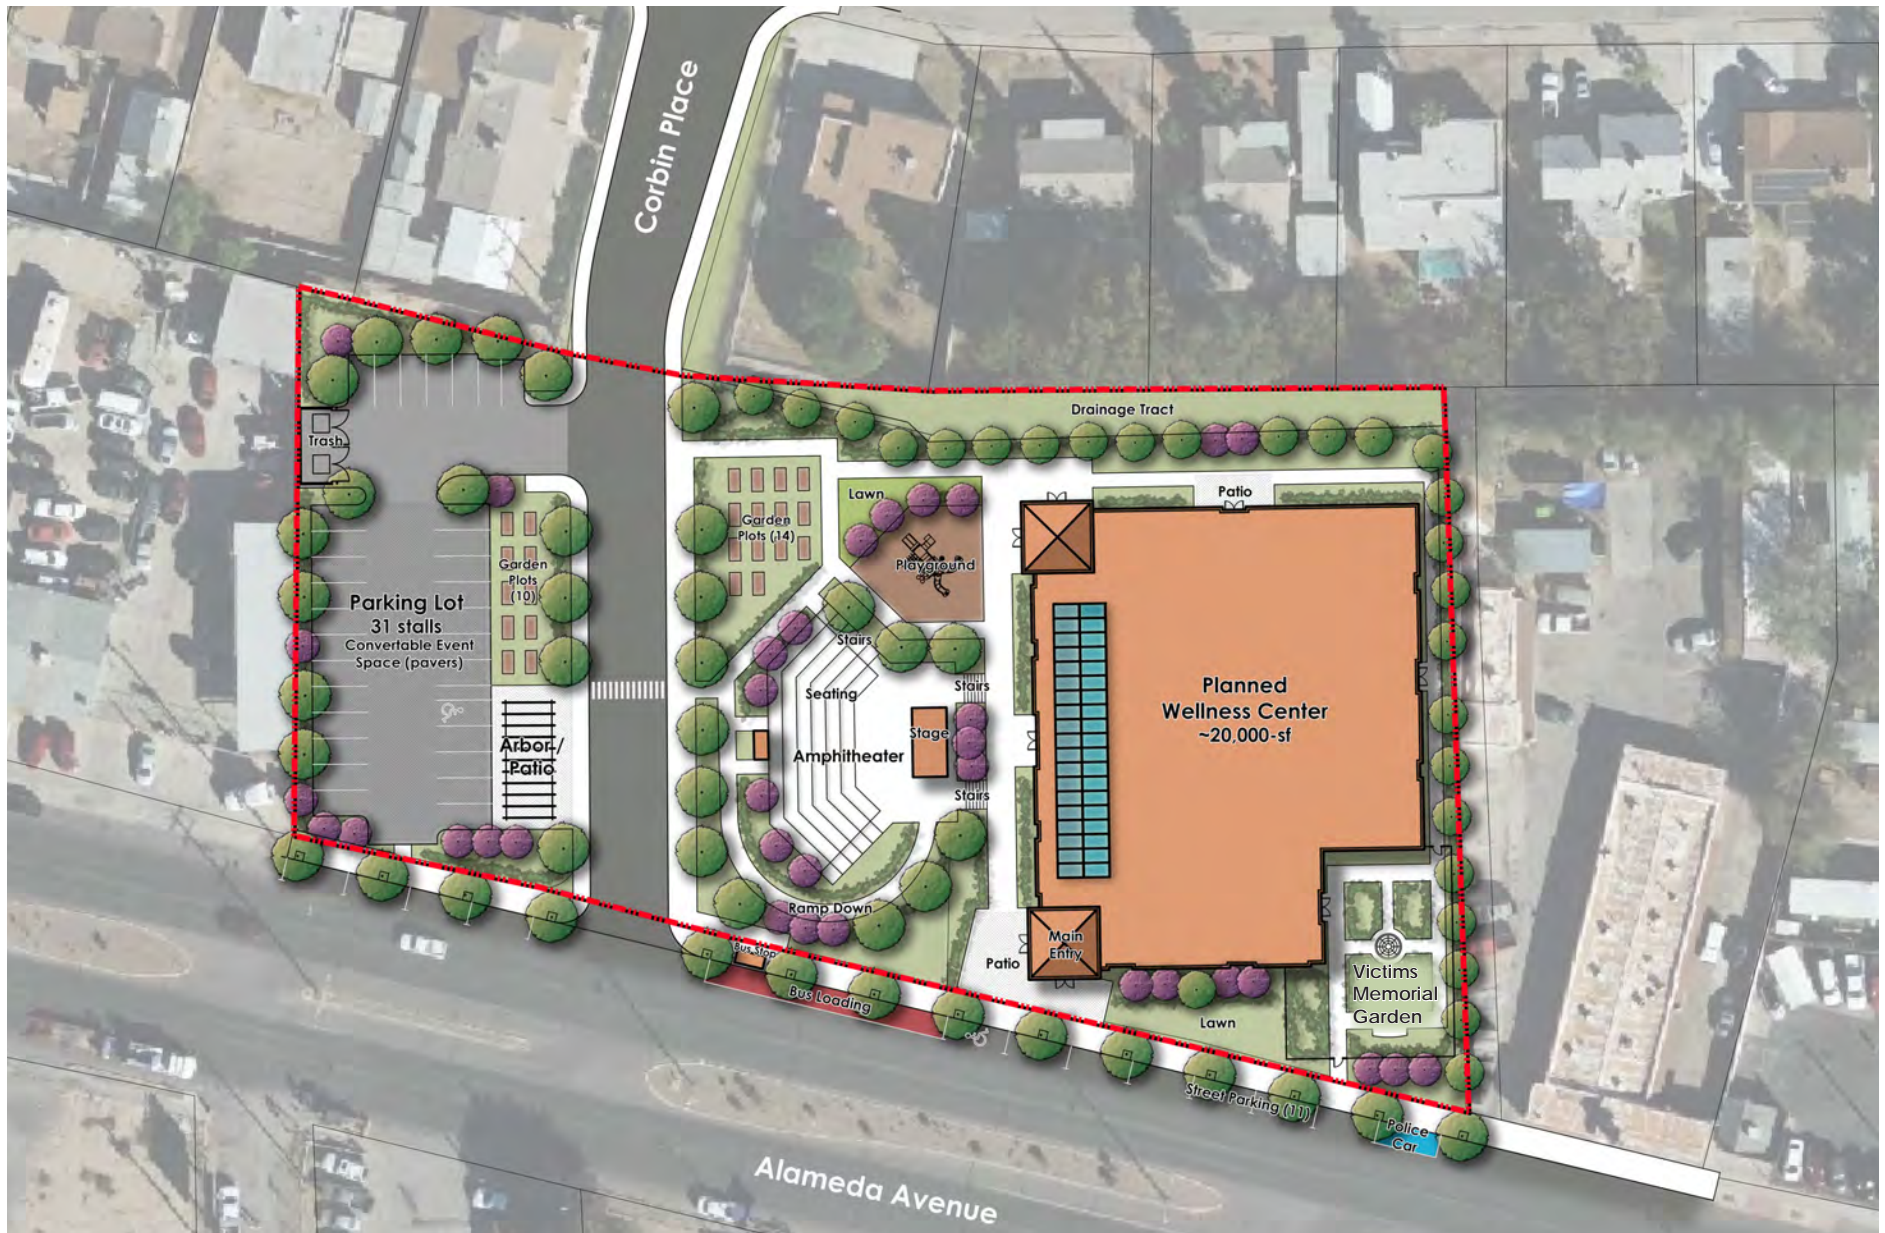
Figure 3.3.1. Preferred Reuse Plan for the Corbin-Sambrano Property

Figure 3.3.1 depicts the locally preferred conceptual reuse plan for the Corbin-Sambrano property. The subsequent pages show representative images of various planned site components. The County and the community can use this document (and its plans/illustrations) to guide final design and implementation.

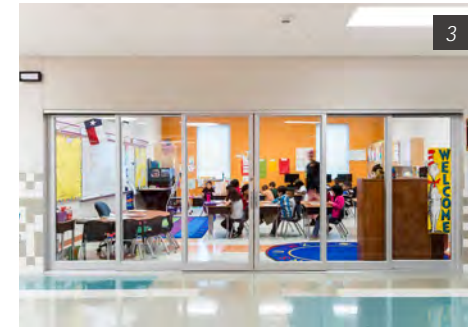
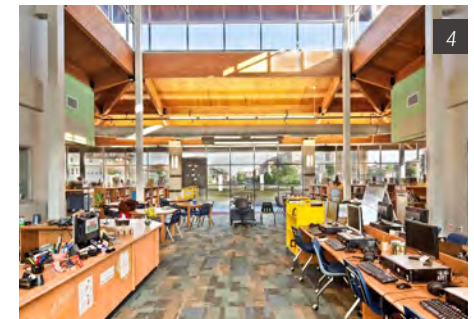
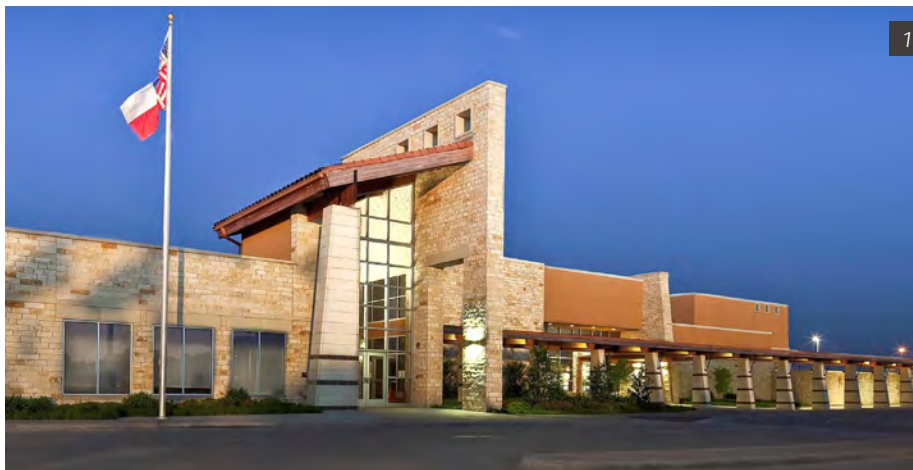
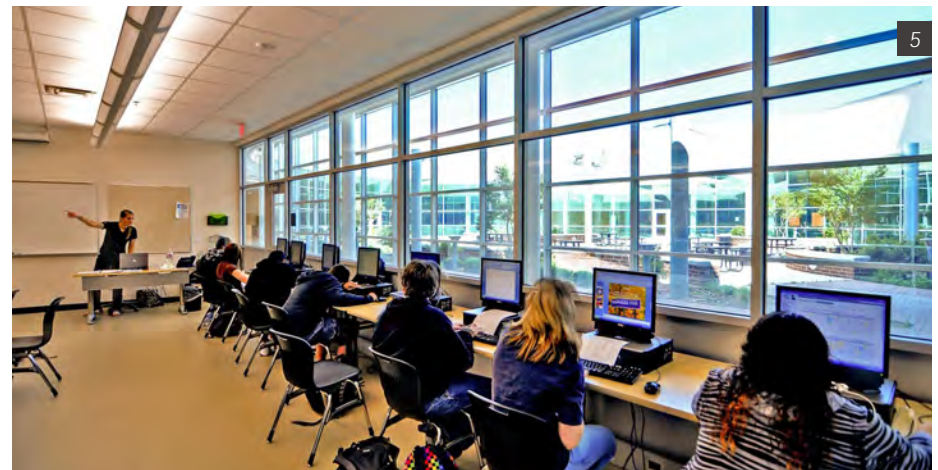
1. Example of a public building with quality materials and covered outdoor areas. | 2. Example of a glass atrium feature which is planned for the front portion of the Wellness Center (Source: ryunosuke-kikuno | unsplash.com). | 3 & 4. Examples of flexible interior spaces for enrichment programs. | 5. Example of a media center with internet access for community members.

Wellness Center Building – The plan includes a new 20,000-square foot community wellness center with its main entrance oriented to both Alameda Avenue and Corbin Place. The building is planned to contain programs for victims of crime, other social services, and community enrichment. There will be office space for resource programs and flexible spaces for the myriad of enrichment and educational programs; those areas are tentatively planned as flexible interior spaces with retractable walls (so rooms can be tailored to the individual programs). The building will include multimedia resources (e.g., internet, computer terminals, etc.), restroom facilities, a kitchen (for events), and storage. The western portion of the building is conceptually planned with a glass atrium to bring in natural light – the reception, lobby, leisure space, and multimedia stations could be planned in this area. The building includes multiple entrances to connect to various outdoor use areas.

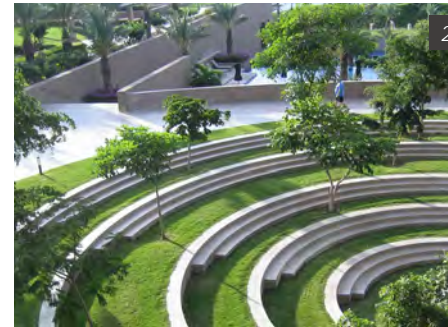
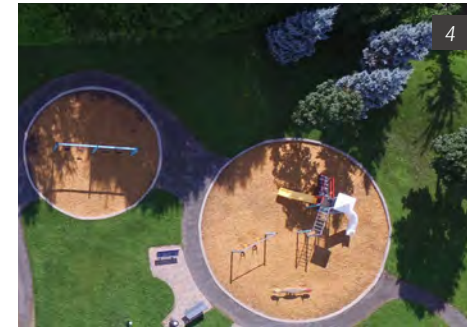
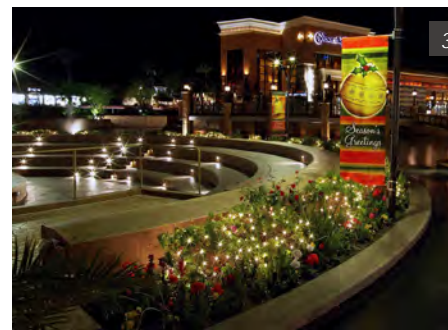
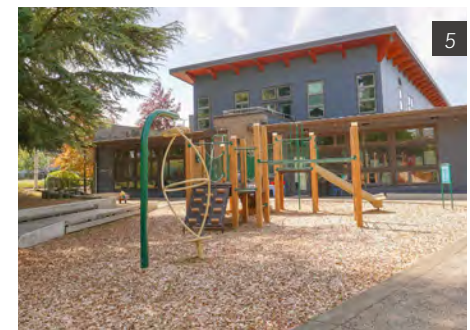
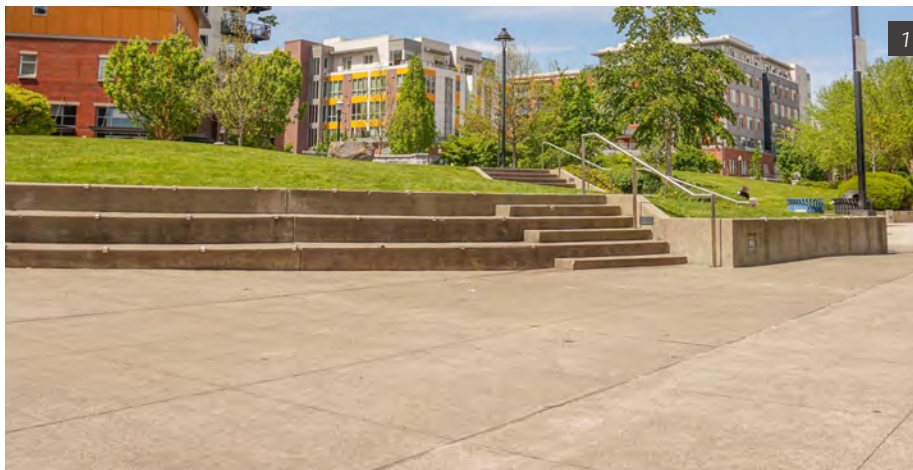
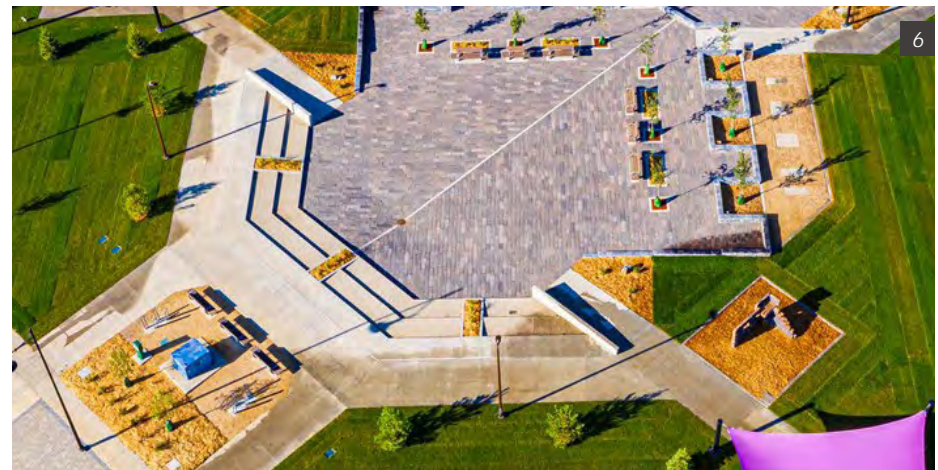
1. Example of a small amphitheater as part of a public building in Burien, WA. | 2. Example of a grassed amphitheater with shade trees (Source: silent-singer | unsplash.com). | 3. Night time example of a public amphitheater (Source: MBH Architects) | 4. Example of a tot lot with shade trees (Source: droneflyer-nick | unsplash.com). | 5. Example of a playground outside a community center in Seattle, WA. | 6. Example of a recessed plaza area.

Amphitheater – A ~200-seat amphitheater is planned along the Corbin Place right-of-way and along the Wellness Center’s western facade. The amphitheater is designed as a depressed area to allow for terraced seating; stairs are planned as part of the seating and leading down from the Wellness Center. A curved ramp is planned on the south side to meet Americans With Disabilities Act (ADA) requirements, allow for equipment setup, and accommodate community members with mobility impairments. Given its location and the El Paso climate, the final design should incorporate shade elements to protect occupants from the sun.

Playground – A new playground area with a small lawn is planned just north of the amphitheater and just outside one of the Wellness Center building entrances. The playground is planned with a variety of recreational equipment including slides, swings, and climbing bars. Soft ground cover should be installed to protect children from falls and to deflect sun light. Landscaping will provide shade and buffer the playground from the adjacent residential properties. The playground location provides natural surveillance and would complement community events at the adjacent amphitheater.
