El Paso Downtown Management District Quarterly Progress Report #7 (3Q22)

FY2020 EPA Brownfield Assessment Coalition Grant (BF-01F87401)

July 26, 2022

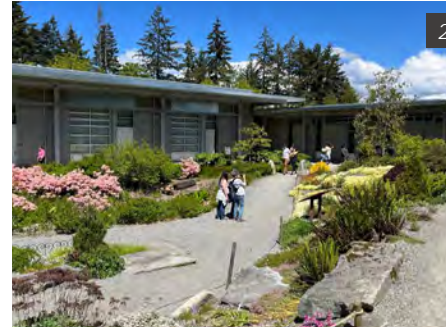
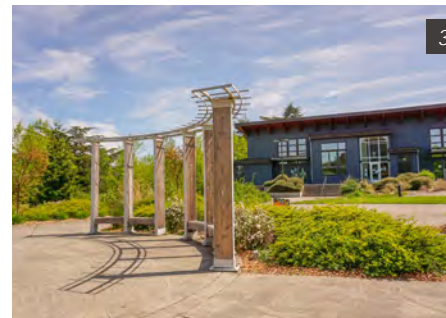
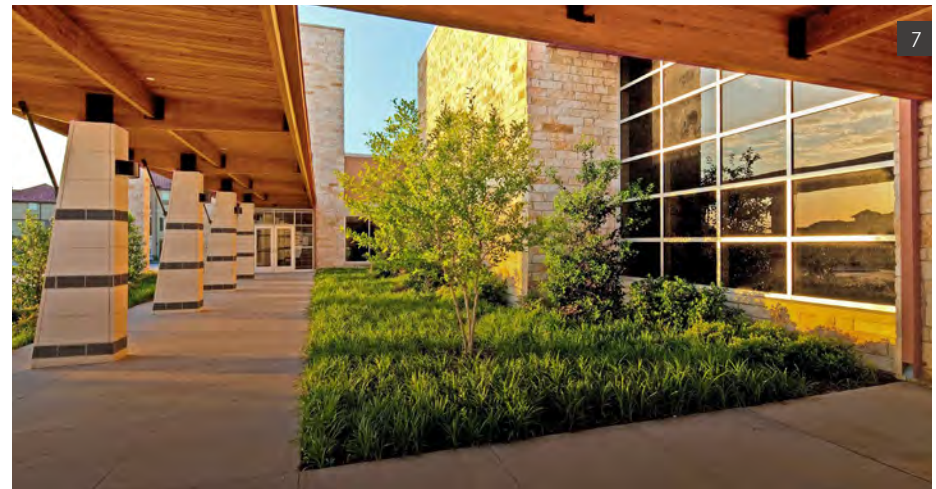
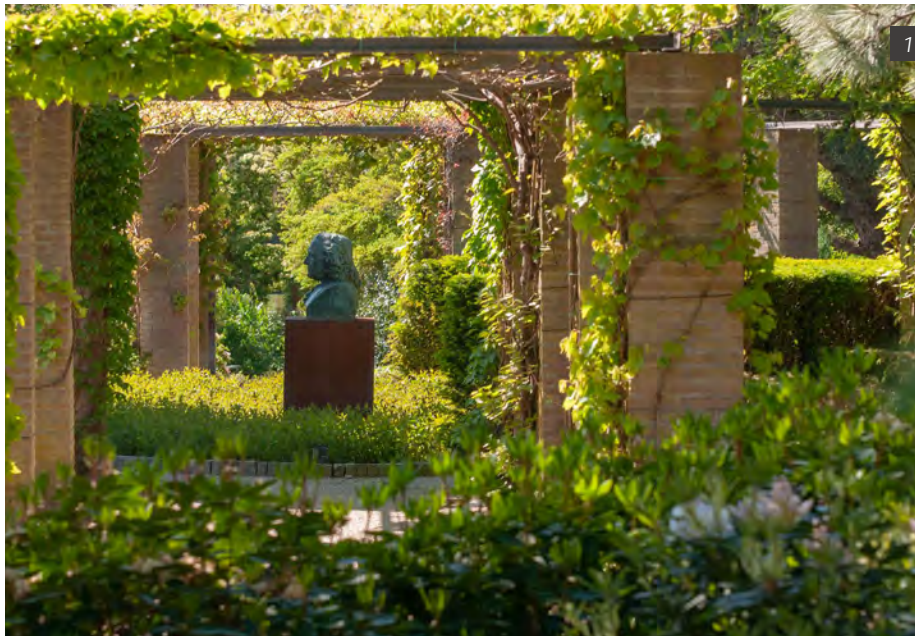
1. Example of an enclosed garden (Source: jos-zwaan | unsplash.com). | 2 & 3. Examples of public gardens as part of a public building. | 4 & 5. Examples of murals that reflect community history (Source: leo-kwan | unsplash.com). | 6. Example of community garden plots. | 7. Example of landscaped areas around public buildings.

Victims Memorial Garden – A new Victims Memorial Garden (also referred to as the “healing garden”) is planned within a secured courtyard area to the back of the Wellness Center Building along Alameda Avenue. The garden is planned at the exact location of the theater building; the garden is intended to pay homage to crime victims and provide an area for peace and reflection to those individuals seeking protection and social resources. The eastern wall surrounding the garden will contain a Victims Memorial Wall as requested by the District Attorney.

Garden Plots – The reuse plan includes ~24 raised garden plots in two areas along Corbin Place. The plots could be leased/assigned to community members to cultivate plants and vegetables to address food insecurities, add community activity, and provide another neighborhood resource.

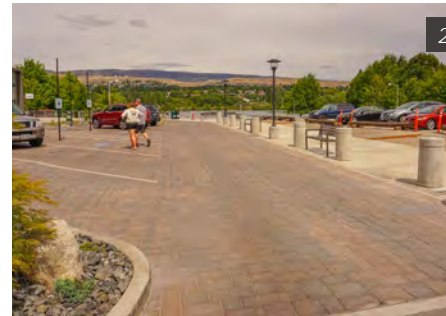
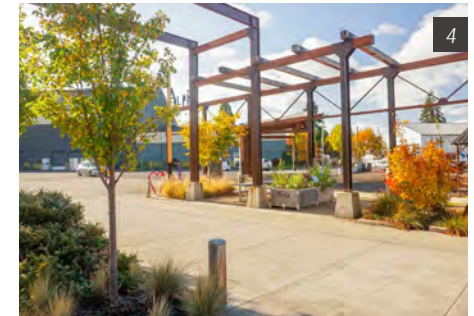
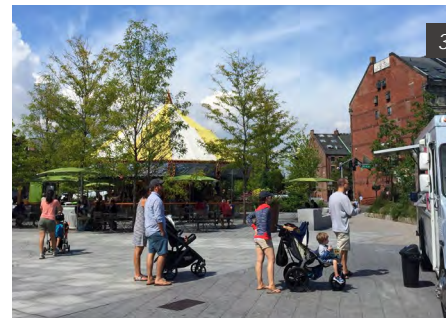
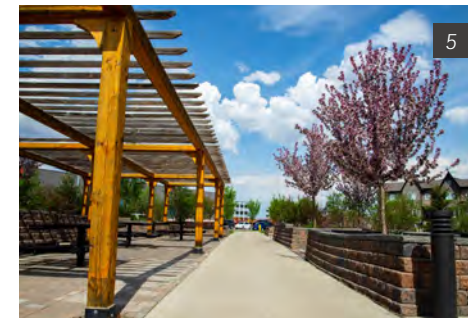
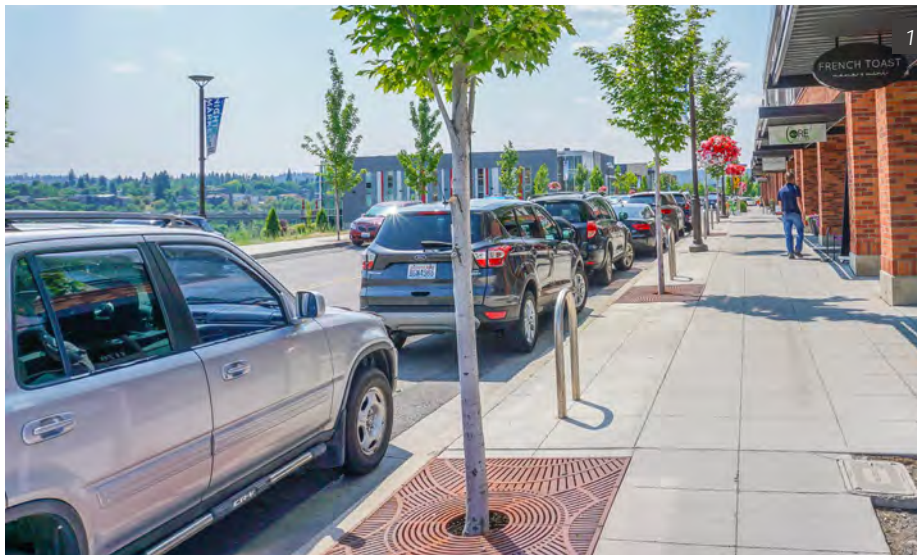
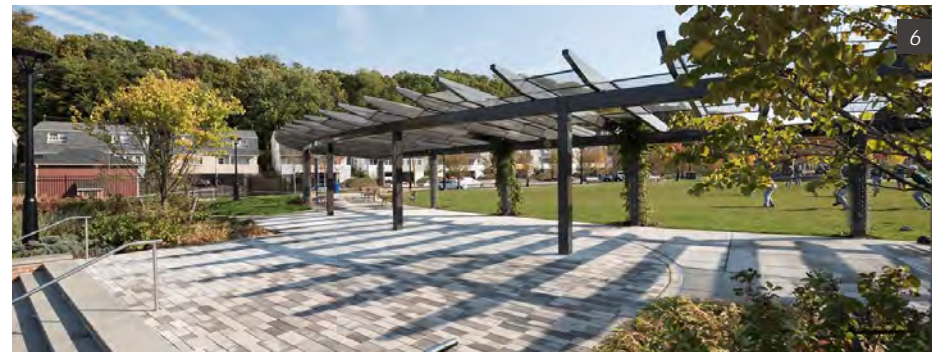
1. Example of roadway frontage improvements with wide sidewalks, tree wells, and street parking like those envisioned along Alameda Avenue. | 2. Example of a public parking lot with pavers. | 3. Example of a convertible public space that can be converted for community events and mobile vendors. | 4 & 5. Example of arbor features along local roadways like the one envisioned for Corbin Place. | 6. Example of an arbor structure that frames a community gathering space.

Parking/Convertible Event Space – The reuse plan depicts a new parking lot on the western most lot (west of Corbin Place) which would accommodate up to 31 motor vehicles. The southern portion of the lot is planned as concrete pavers so that space can be periodically used for outdoor community events; pavers allow for stormwater to percolate into the ground (with limitations), reduce heat absorption, and create a more comfortable surface when compared to asphalt. An arbor structure and paver area are planned between the parking lot and Corbin Place to further accommodate community events and provide shade elements; this feature will visually connect the parking lot/event space with the Wellness Center. The reuse plan also depicts frontage improvements along Alameda Avenue which would include 11 striped street parking stalls, a designated stall for a police/sheriff vehicle, and a bus loading area (and shelter). The frontage improvements also include 10-ft wide sidewalks and evenly spaced tree wells. Notably, the El Paso zoning code allows for administrative flexibility to the City’s parking standards; a combination of on-site and street parking is planned to meet the property’s parking requirements.
